Delaware River
Joint Toll Bridge
Commission

2018 TOLL-SUPPORTED BRIDGE ANNUAL INSPECTION REPORT

FEBRUARY 15, 2019

Re: General Engineering Consultant
2015 – 2020 Annual Inspections
DRJTBC Contract No. C-684A
**2018 Toll-Supported Bridge
Annual Inspection Report**

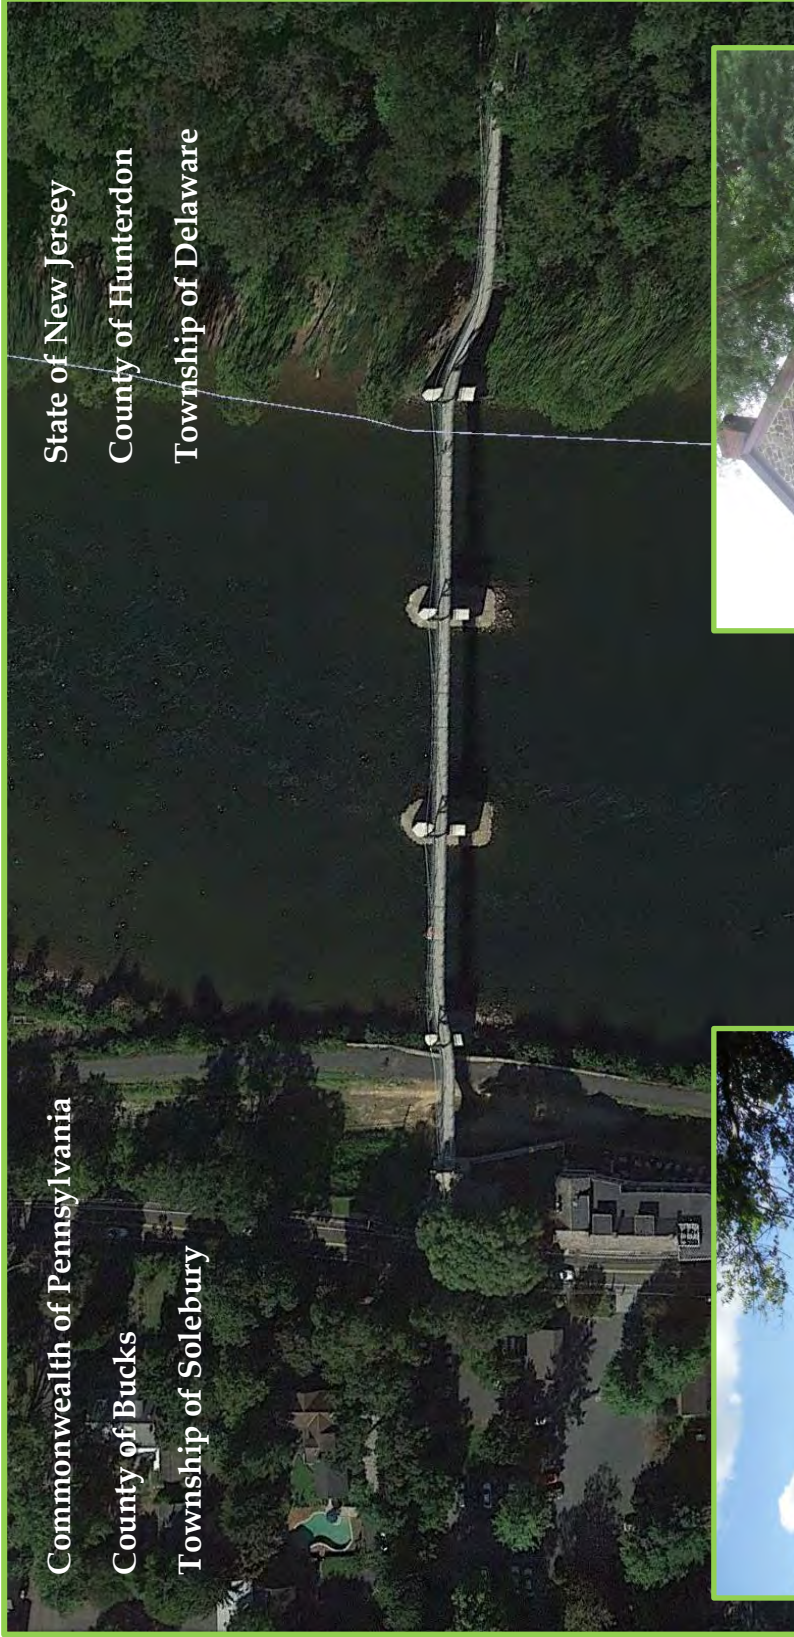
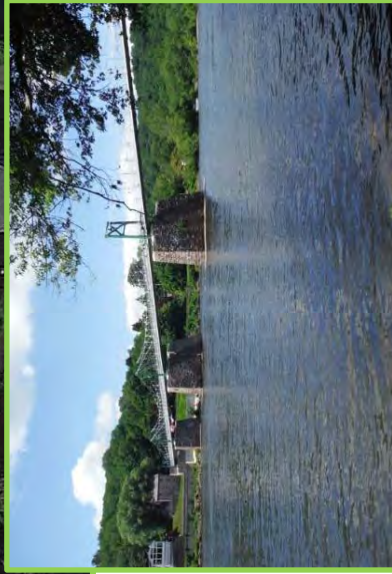
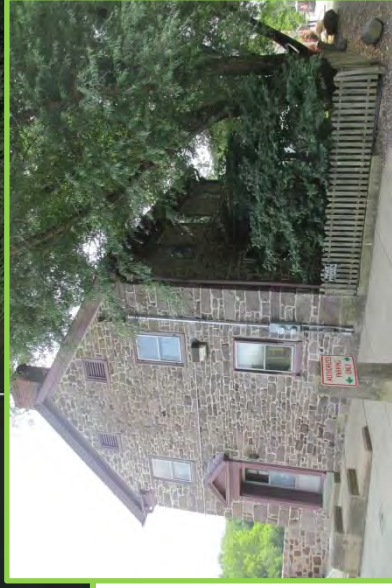
LUMBERVILLE - RAVEN ROCK
TOLL-SUPPORTED PEDESTRIAN BRIDGE
(Structure No. 180)

A major rehabilitation contract was completed in 1993 that included a new deck slab, pier and abutment repointing, approach sidewalks and bridge lighting. A comprehensive rehabilitation of the Lumberville Raven Rock Toll-Supported Bridge was completed in 2013 under Contract No. TS-443A. The rehabilitation work included structural steel repairs, cleaning and painting of all structural steel, substructure repairs and reconstruction of Pennsylvania retaining wall.

The substructure above the waterline is in satisfactory condition. Loose and missing stones, voids in the masonry, and deteriorated pointing were noted. A large area of deep scaling with exposed reinforcement was noted at the concrete nose at Pier 2.

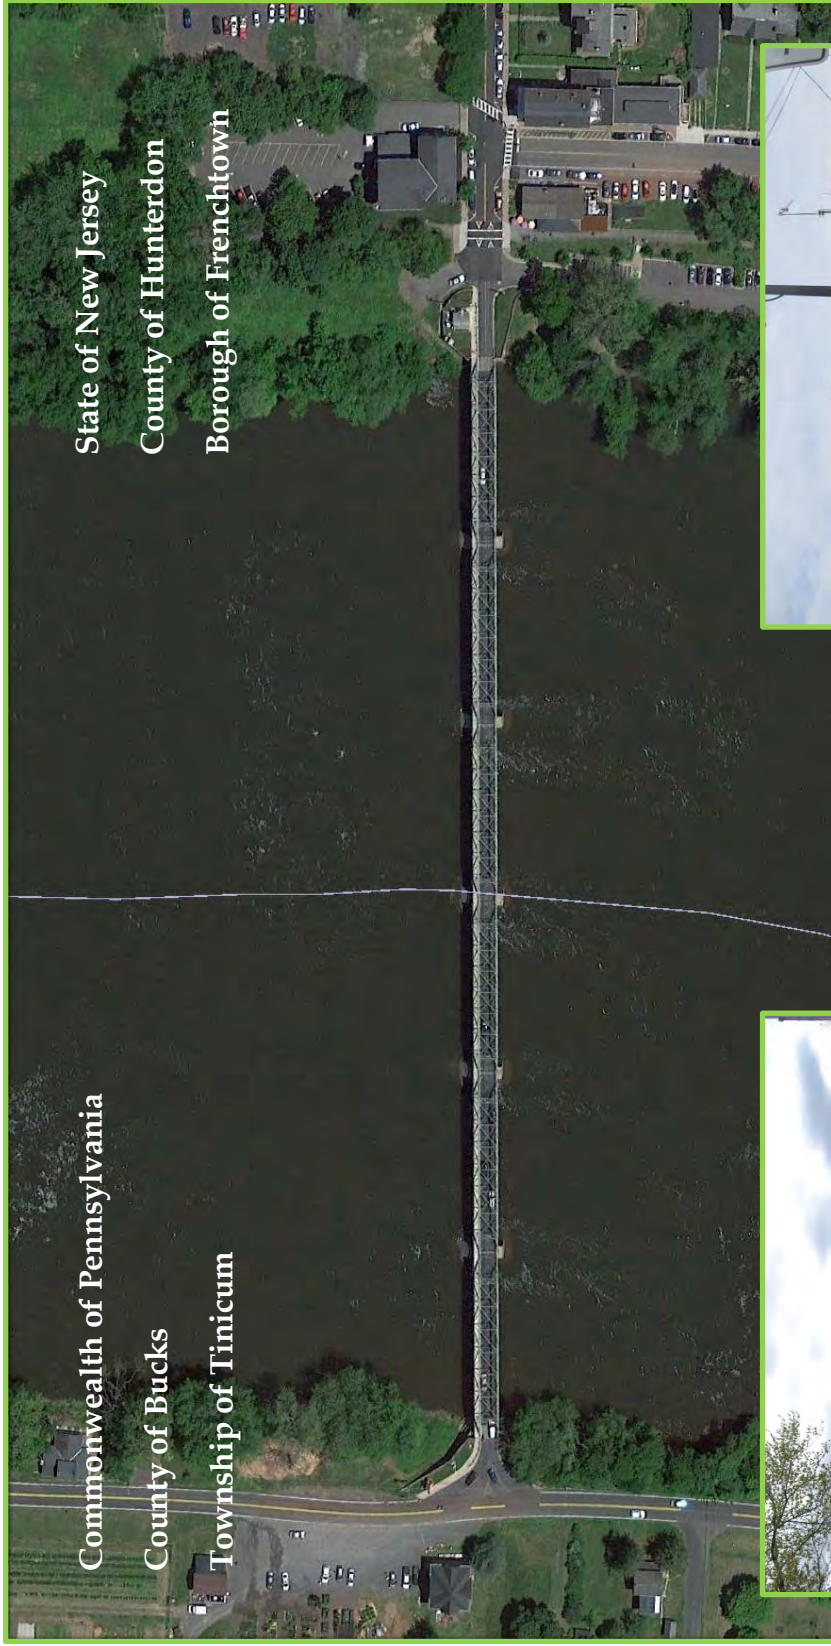
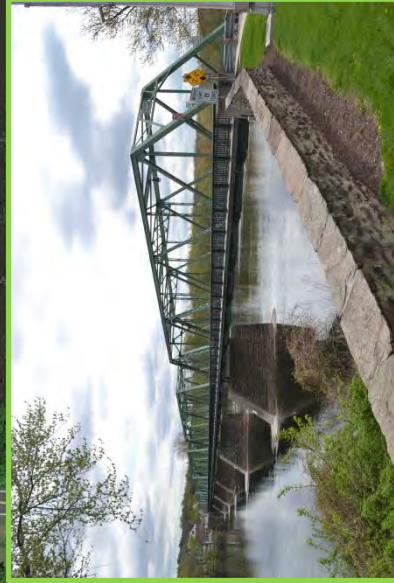
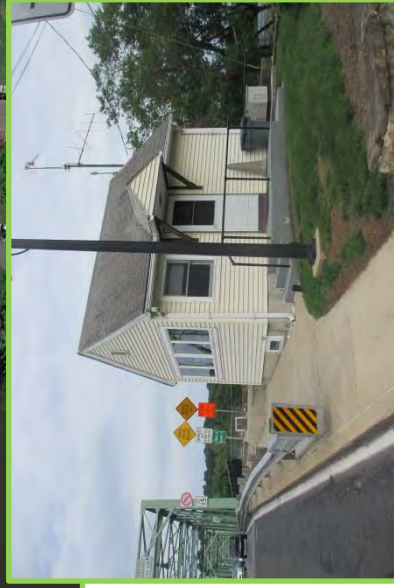
(Structure No. 220)

The structure was rehabilitated in 2001 under Contract No. TS-363. Major work items included floor system, deck and sidewalk replacement, cleaning and painting of truss members and substructure repointing.

The substructure above the waterline is in satisfactory condition. Areas of cracked and missing mortar were observed on the masonry portions of the substructure units. Scattered cracks and spalls were observed on the concrete bridge seats.

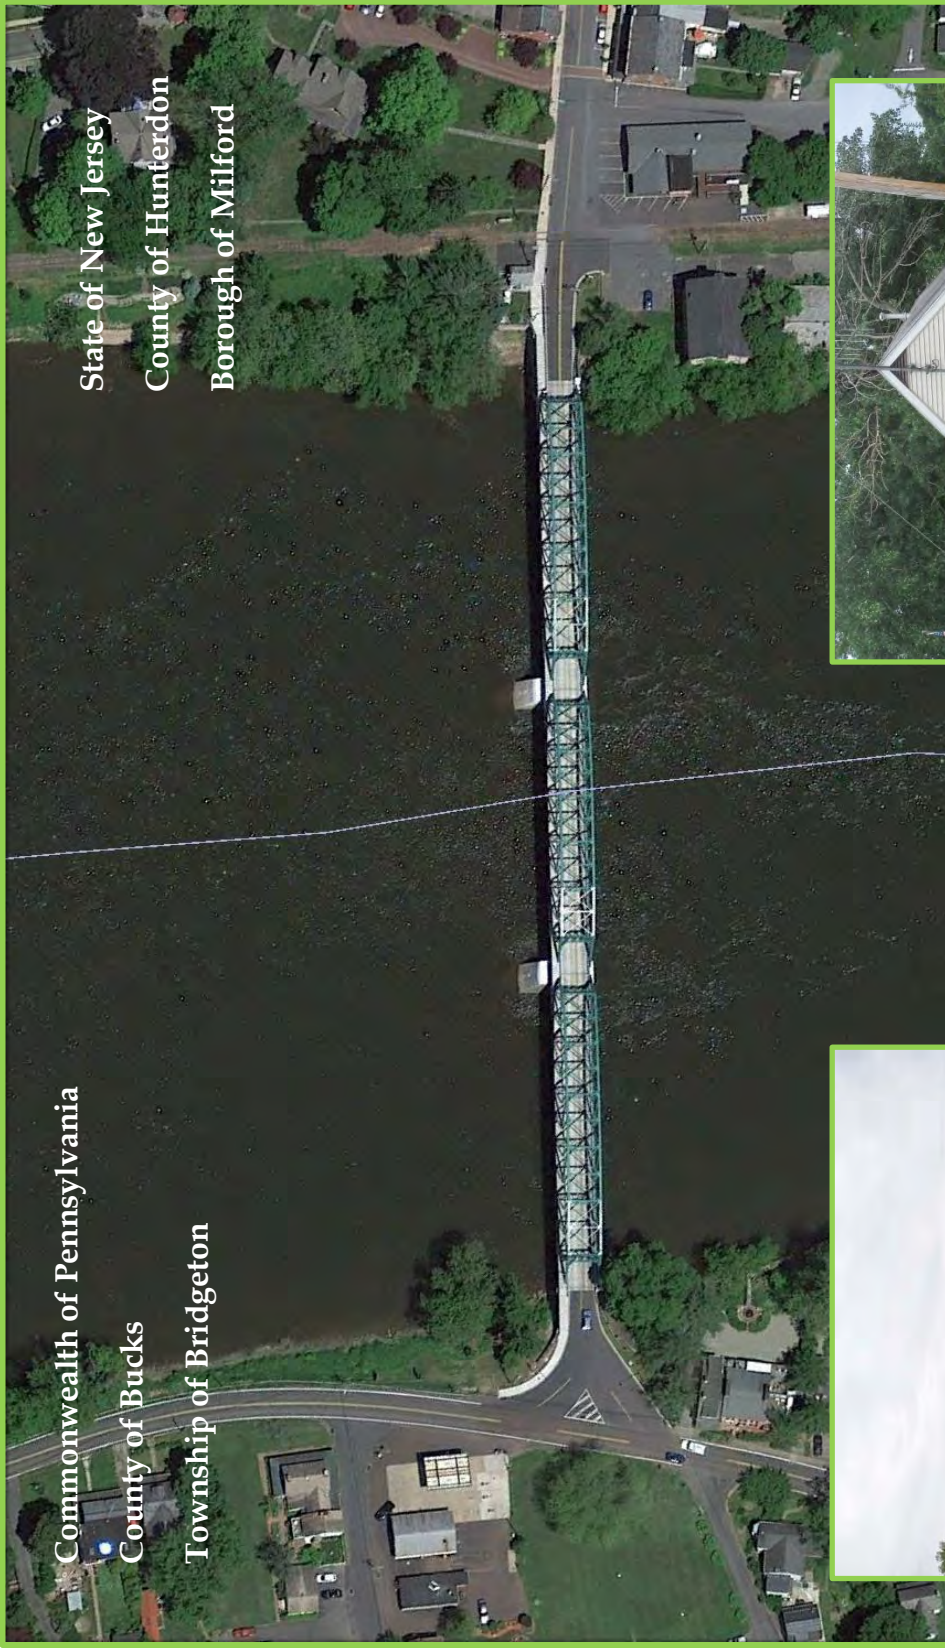
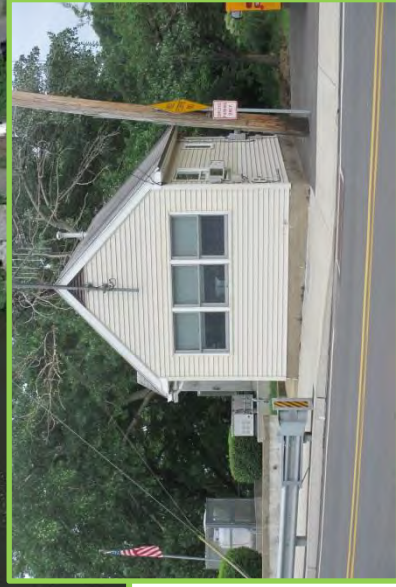
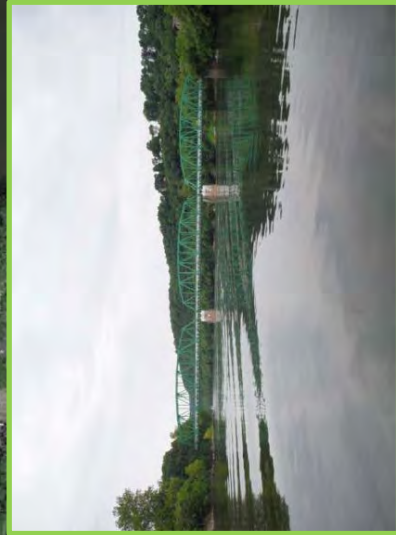
UPPER BLACK EDDY - MILFORD
TOLL-SUPPORTED BRIDGE
(Structure No. 240)

The bridge, constructed in 1933, is a three span Warren Truss structure, with a total length of approximately 700 feet. The deck, replaced in 2011, consists of concrete filled steel inverted “T’s” and provides a curb to curb width of 20 feet. Both abutments, recapped with reinforced concrete following flood damage, were originally built in 1842 with rubble faced masonry. The piers, built in 1842, are stone filled having also been recapped with reinforced concrete.

A comprehensive rehabilitation was completed in 2011 under Contract No. TS-444A. Major work items included floor system, deck (concrete filled steel grid) and sidewalk replacement, cleaning and painting of truss members and substructure repointing.
